Capsule Summary  
SM-770  
Four Tobacco Barns  
Oakley vicinity  
Private

## Maryland Inventory of Historic Properties Form

Inventory No. SM-770

Name Middleton Tobacco Barn A  
Addendum

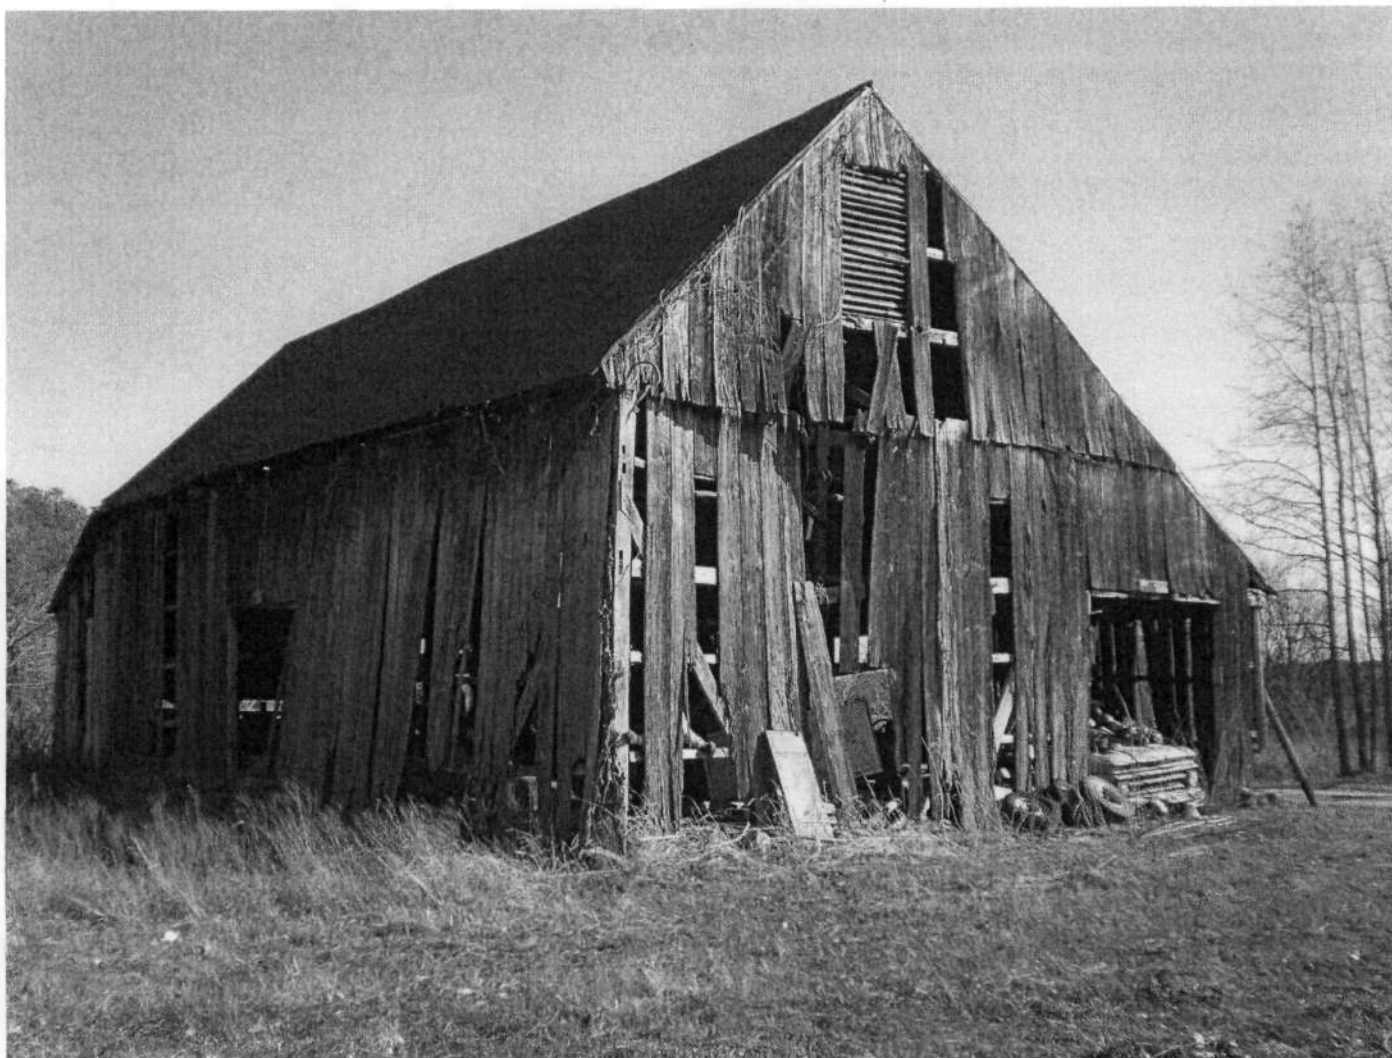
SM-770 Middleton Tobacco Barn A  
Avenue, St. Mary's County  
Photo by Center for Historic Architecture and Design Staff  
Looking southeast  
January, 2008

Barn A displays a cross-axial plan oriented east to west. Seven bays divided the barn, with three eight foot bays on each side of a twelve-and-a-half foot central door bay. A door would have been centered on each gable end, although the west gable end has now been covered with a shed and the door removed. Timbers within the barn are a mixture of hand-hewn and pit-sawn, fastened with a combination of pegged mortise-and-tenon and nailed half-lapped joints. All primary joints are labeled with carpenter's marks. Two cross-sills transect the barn on either side of the central aisle. The large central aisle suggests the barn was equipped from the beginning for horse-drawn wagons which would have needed to enter through one door and exit through an opposing door. Another cross-sill runs the length of the barn at the center of its width, directly below the roof's ridge. This cross-sill terminates at the central aisle and starts anew on the other side while supporting a hanging tier system. Each hanging tier is comprised of two posts (averaging two by three inches) spaced an average six inches apart. A round peg stretches between the posts at every tier supporting the ends of stripped sapling tier poles which then extend to the north and south walls. The barn's structure rests on intermittent brick piers.

Vertical board siding covers the barn punctuated by an irregular combination of top- and side-hinged vertical board vents. A gable roof, continuous over both the barn and a shed on the barn's south elevation, is covered with corrugated sheet metal. Rafters are on four-foot centers and rest on a flat false plate. Each rafter is supported by three collars.

The shed on the barn's south elevation measures seventy-four-and-a-half by fourteen feet and may be original. Major timbers within the shed are hewn and exhibit carpenter's marks similar to those in the barn. In addition, the rafters of the barn's roof rest on the shed's false plate making the shed fully included in the barn's roof. However, if the shed was added early, the barn's roof could have been replaced to accommodate the new shed. A Period II or III shed on the barn's west elevation is supported by a mixture of round and sawn posts and dates to later period.

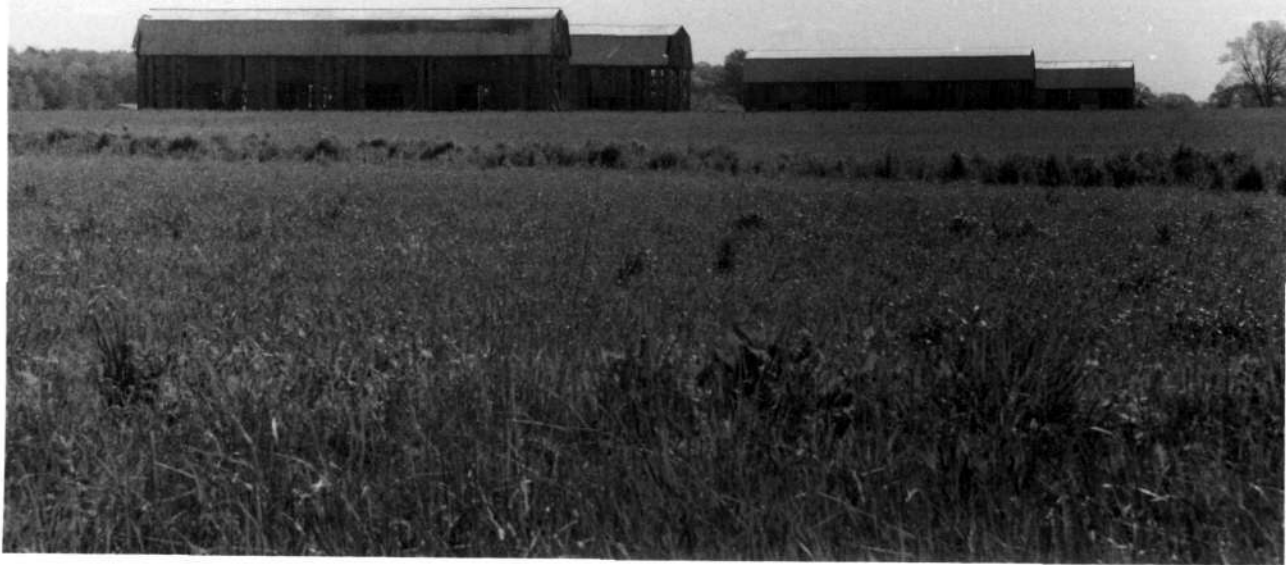
1 of 1

Four Tobacco Barns - Oakley

Looking E

Probably constructed in the mid-twentieth century, the four frame tobacco barns feature long rectangular plans with side gable entries. Standing on concrete pier foundations, the barns are sheathed with vertical boards. The gambrel roofs are covered corrugated metal. Unlike many contemporary barns, all of the tobacco barns feature four side gable through tractor-ways rather than axial plans that extend the entire length of the building from gable end to gable end.
